Fish Passage Surveys

-Harley Road Culvert-

Olleycology Limited

8th March 2023 (revised 31st June 2023)

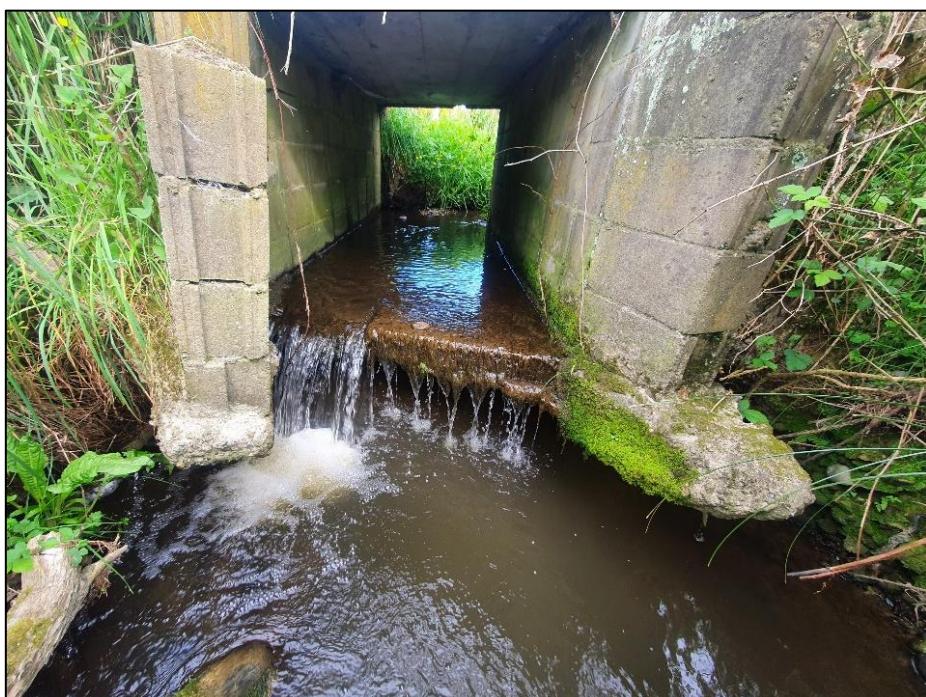
This report details the findings of fish surveys completed at a culvert crossing of a small tributary of Field Stream, named hereafter as “Harley Creek” (Figure 1). The crossing is located approximately 1.2 kilometers inland from the Moutere Inlet and it the first structural barrier fish would encounter while moving up from the coast. The box concrete culvert is 1.25 m wide, 3 m long, has a gradient of 1% and max water velocities of 0.4m/s (Table 1). The culvert was also perched 0.45 m and undercut 1 m (Figure 2).

It was considered likely that the drop at the culvert outlet was impeding successful upstream passage of all fish species likely to be found within the catchment. The low gradient and roughened surface on the culvert floor were likely allowing complex flows and water velocities within the swimming capabilities of all fish species likely to be found within the catchment.

Figure 2. Perched box culvert at Harley Creek prior to remediation.

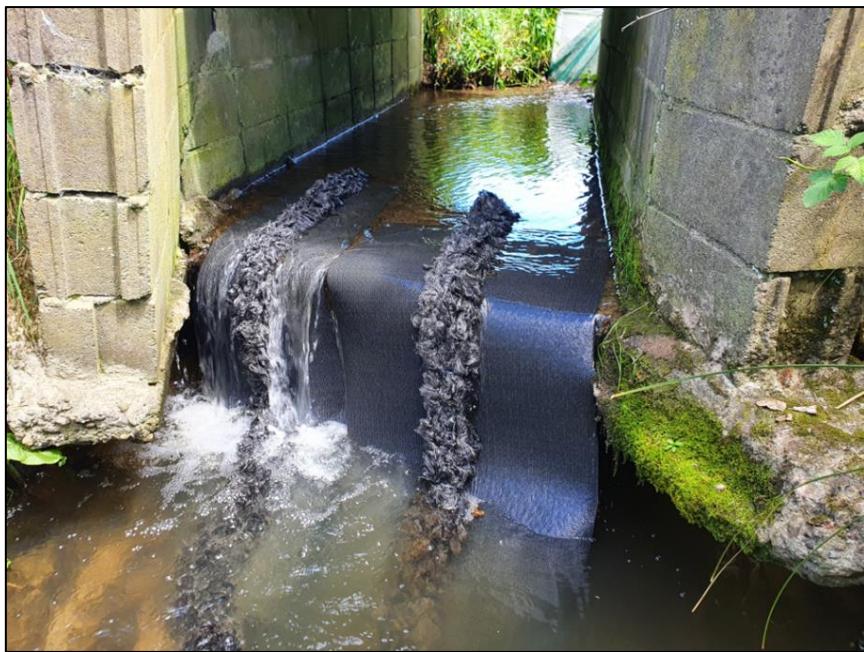
Figure 6. Two flexible rubber ramps with mussel-rope at the culvert outlet.

Damage to the culvert floor had resulted in uneven flow at the structure outlet, therefore two ramps were used, one within the high flows on the true right and one within the low flows on the true left. With reference to the Fish Passage Remediation Training Aid 2022, the flexible fish ramps, both made of reinforced PVC rubber, were installed at the culvert outlet to negate the perch (Figure 6). The ramp sizes were 300mm x 1800mm and 700mm x 1800mm respectively and lay vertical. The ramps were fixed to the culvert floor with stainless-steel wedge anchors (M6.5 x 40 mm) and stainless-steel penny washers (32 mm) and included a bundle of looped mussel-rope fixed to the ramp invert running down the center of each ramp (figure 6).

Flexible ramps with mussel-rope are designed to offer aquatic species several choices when migrating e.g., passage over/through mussel-rope, adjacent to mussel-rope or on the wetted margins at the edges of the ramp.
