Fish Passage Surveys

-Williams Road Culvert-

Olleycology Limited

29th June 2022 (Revised 31st June 2023)

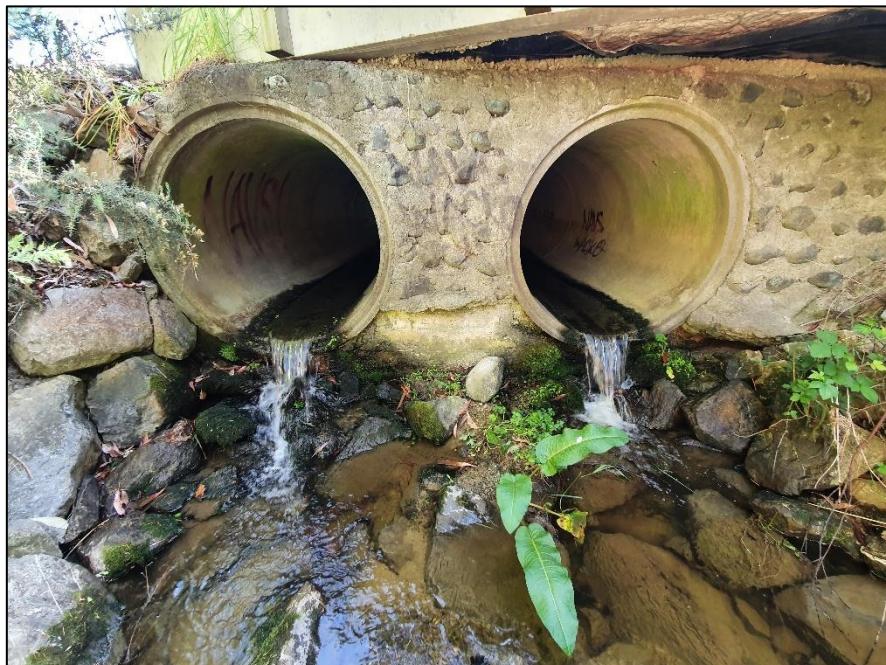
It was considered likely that the drops at the culvert outlets were impeding successful upstream passage of at least some fish species. While relatively low in gradient, the laminar flow and water velocities within the culverts may have also been acting as a barrier to fish.

Figure 2. Perched culverts at William's Creek prior to remediation.

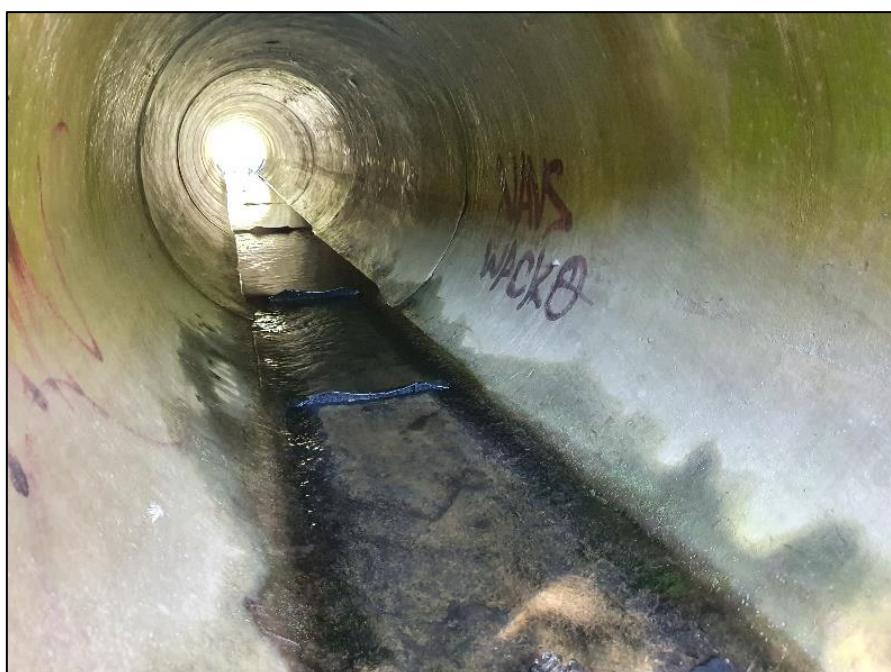
Figure 6. Flexible baffles within the true left-hand culvert pipe.

With reference to the Fish Passage Remediation Training Aid 2022, a total of seven flexible baffles were secured within the true left culvert pipe to reduce water velocities and create resting pools (Figure 6). All seven baffles were 450 mm wide and 100 mm high with slits at 50 mm spacing. 45-degree cuts at both ends to allow fish passage around the baffle. The spacing between baffles, and the number of baffles installed, was determined by the culvert gradient. Where gradients were between 0-1%, baffles were spaced at 2.4m intervals. Where gradients were between 1-2%, baffles were spaced at 1.2m intervals.

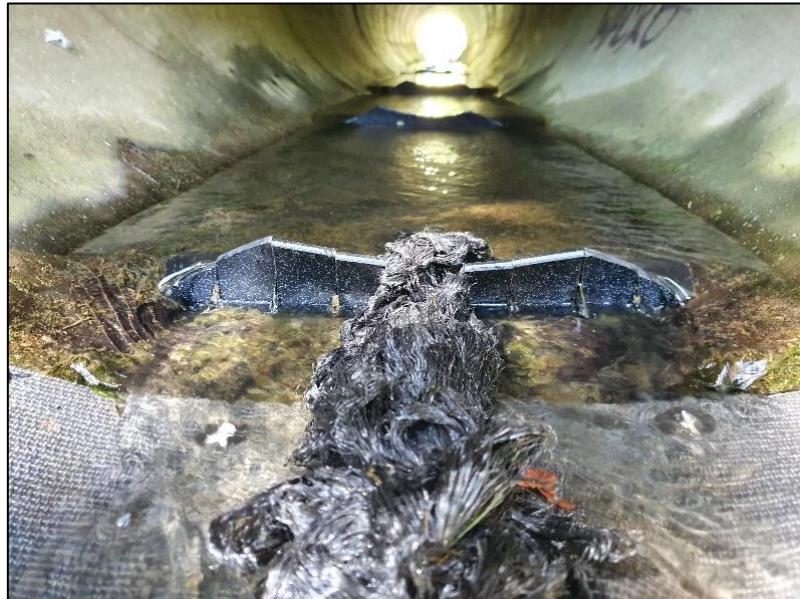
Figure 7. V-baffle and mussel-rope at the culvert outlet.

The most downstream baffle had a “V” cut midway through to enable rope to pass through the baffles and for it to be secured immediately upstream (Figure 7). This allows fish an opportunity to transition into the pipe either using climbing or swimming modes. The baffles were attached to the concrete culvert floor with stainless-steel wedge anchors (M6 x 50 mm) and stainless-steel penny washers (32 mm).

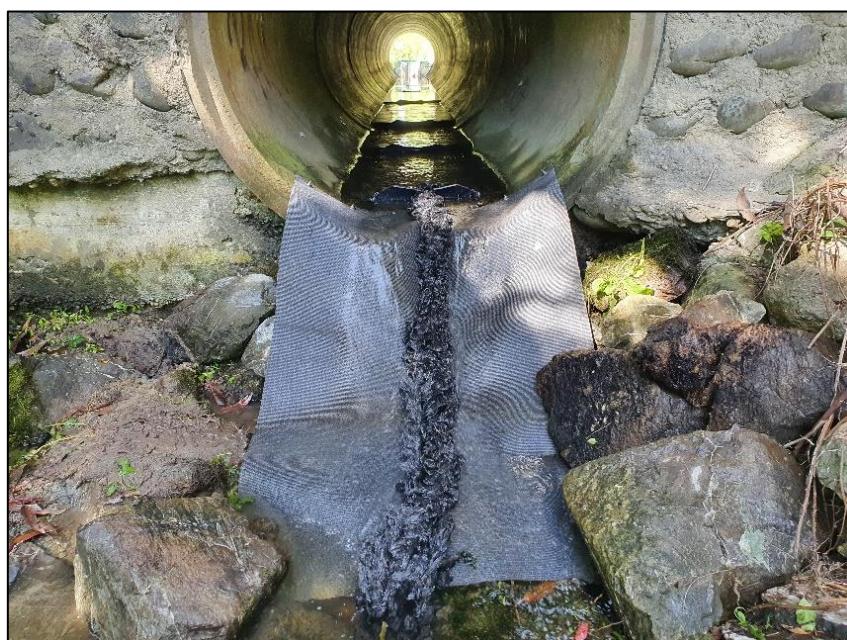
Figure 8. Flexible rubber ramp with mussel-rope

A flexible fish ramp, made of reinforced PVC rubber, was installed at the outlet of the true left culvert to negate the perch (Figure 8). The ramp was 900mm wide by 1500mm long and laid at a gradient of 40 degrees. The ramp was installed to the culvert floor with the same fixings as the baffles and included a bundle of looped mussel-rope fixed to the ramp invert consisting of four strands of rope. Flexible ramps with mussel-rope are designed to offer aquatic species several choices when migrating e.g., passage over/through mussel-rope, adjacent to mussel-rope or on the wetted margins at the edges of the ramp.

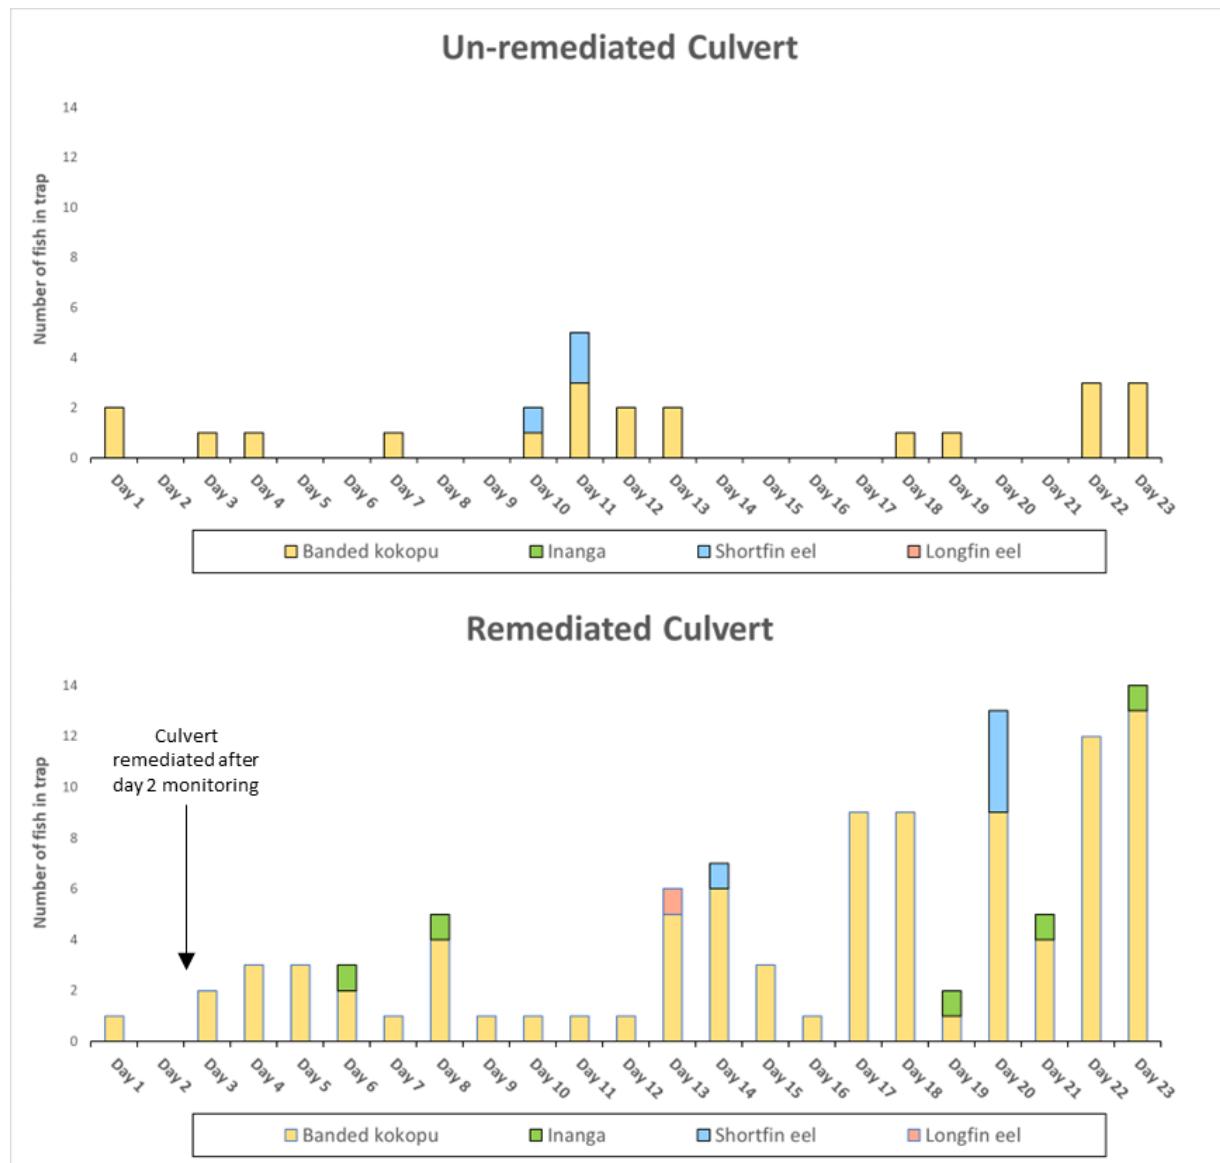
Following fish passage remediation, a total of 102 fish negotiated the remediated culvert over 21 days, compared with 22 fish that negotiated the unremediated culvert (Graph 1).

Graph 1. Numbers of fish caught in the A-frame nets of both the unremediated and remediated culverts.

Banded kokopu made up most of the fish that were caught throughout the experiment, with nearly five times as many moving through the remediated culvert compared to the unremediated culvert. The size range for these fish were 33-80mm in length from the remediated culvert compared to 35-45mm in length from the unremediated pipe.

A small number of shortfin eels (*Anguilla australis*) were also able to negotiate both culverts with five individuals captured in the remediated culvert net and three in the unremediated culvert net over the monitoring period (Graph 1).

Two species of fish, inanga (*Galaxias maculatus*) and longfin eel (*Anguilla dieffenbachii*) were found only in the remediated culvert net. One longfin eel was captured in the remediated culvert net on day 13 while five inanga were captured in the remediated culvert net during the monitoring period (Graph 1). The size range for these inanga were 51-65mm in length.

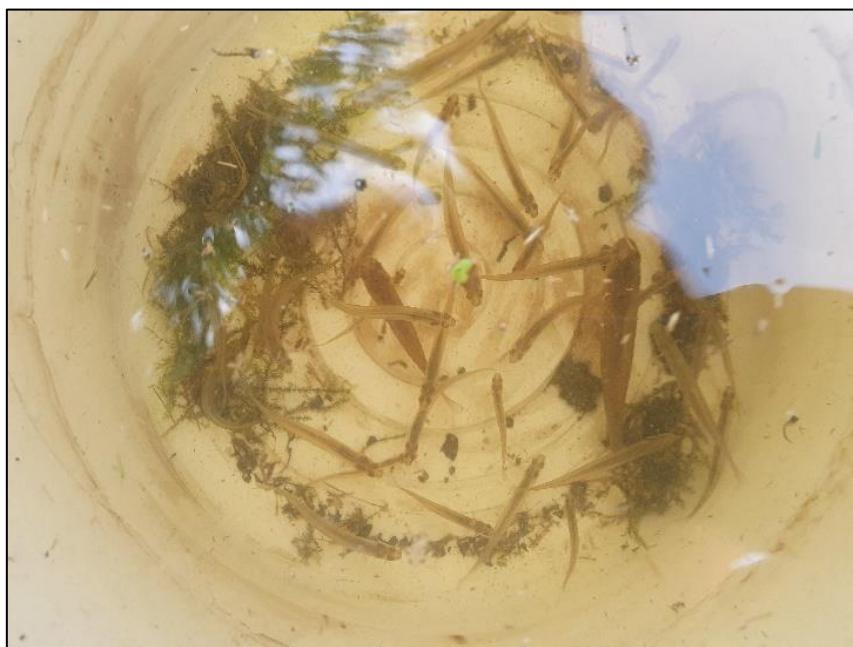
At the conclusion of the monitoring, both culverts were searched to capture and record fish that were still within the culvert pipes. 58 fish were recovered from the remediated culvert pipe and one fish, a banded kokopu measuring 37mm in length, was recovered from the unremediated culvert pipe. Of the 58 fish captured from within the remediated culvert, two were shortfin eels, 20 were banded kokopu and 36 were inanga (Table 2 & Figure 9). The banded kokopu size ranged from 38-100mm in length, and the inanga 47-76mm in length (Table 2). The vast majority of these fish were captured within the top third of the culvert pipe.

Figure 9. Fish recovered from within the remediated culvert at the conclusion of the monitoring.

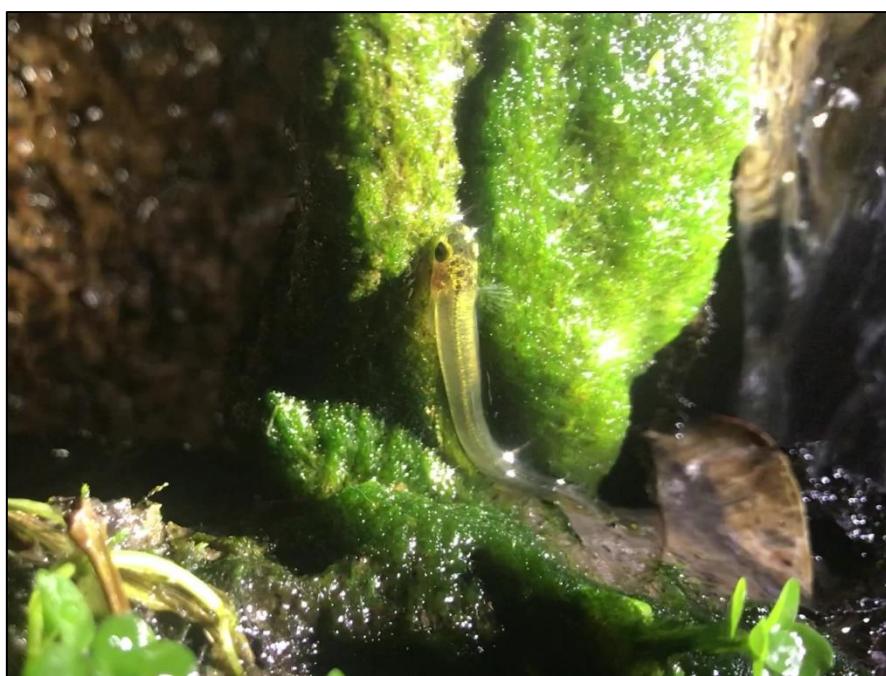
Interestingly, these results suggest that this structure was not a complete barrier to some fish species prior to remediation despite clear perches at both culvert outlets. Juvenile banded kokopu were found in both A-frame nets on day one of the trial before remediation had taken place. Furthermore, banded kokopu and shortfin eels were found to have negotiated the unremediated culvert at various times over the monitoring period. These fish were small, with the maximum fish length 45mm for banded kokopu and 60mm for shortfin eels. The exact pathways these fish took to gain access into the culverts is unknown, however observations have previously been made by the author at the same site in 2020 of fish climbing in the vicinity of the outlets, and opportunistically using a buildup of moss and algae to move into the culvert pipes (Figure 10). Similar opportunities were absent from the culvert outlet during the entirety of this trial; therefore, it is assumed the fish that successfully transitioned prior to the remediation, and via the unremediated culvert, did so by climbing under and around the undercut and moving past the slightly rounded culvert lip. Evidence of other pathways, including between cracks or joins in the culvert pipes were not identified, however one can never rule out the possibility of fish utilising these areas given the opportunity. The small body size of the fish caught prior to remediation, and in the unremediated culvert net throughout the study, likely allowed for greater passage success when climbing up under the pipe undercut.

Figure 10. Banded kokopu juvenile climbing up a build-up of moss and algae at Williams Road in 2020

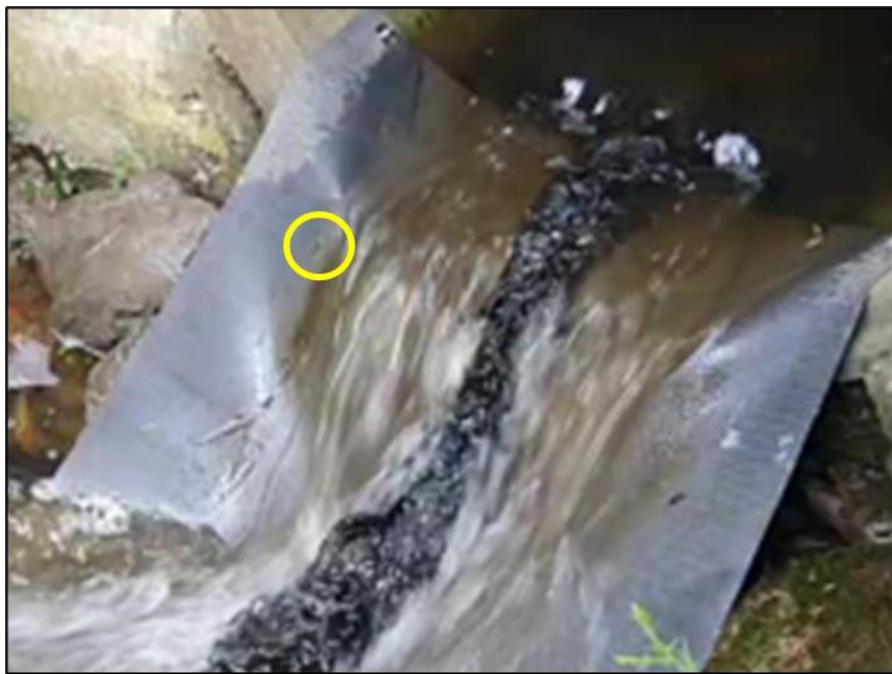
Rainfall and increased flows may have encouraged fish movement into the remediated culvert in the later stages of the trial. A fresh occurred on day 19. Fish were observed using the flexible rubber ramp during these elevated flows. Three pathways on the ramp were used, on the wide wetted margins (Figure 12), adjacent to the mussel-rope bundle within the water column, and within the mussel-ropes themselves (Figure 13). Fish using the areas adjacent to the mussel-rope bundles were only seen for brief moments and whether they were successful in moving into the culvert is unknown. One juvenile galaxiid was seen successfully moving into the remediated pipe on the true right-hand wetted margin of the ramp on day 19 (Figure 12).

Figure 12. Juvenile galaxiid transitioning into the pipe via the true right wetted margin (yellow circle)

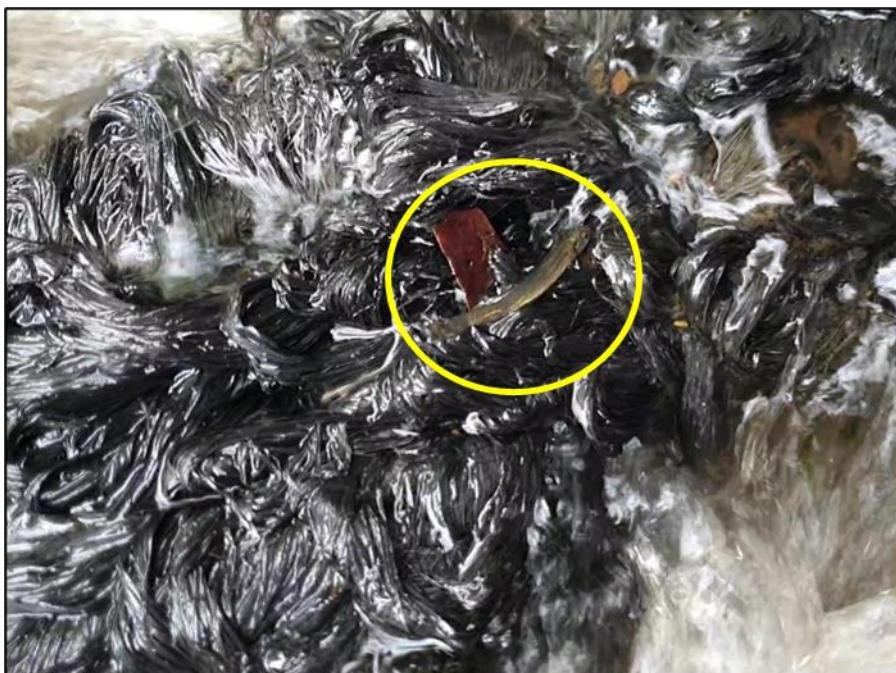
Figure 13. Juvenile galaxiid observed within the mussel-rope bundle (yellow circle)

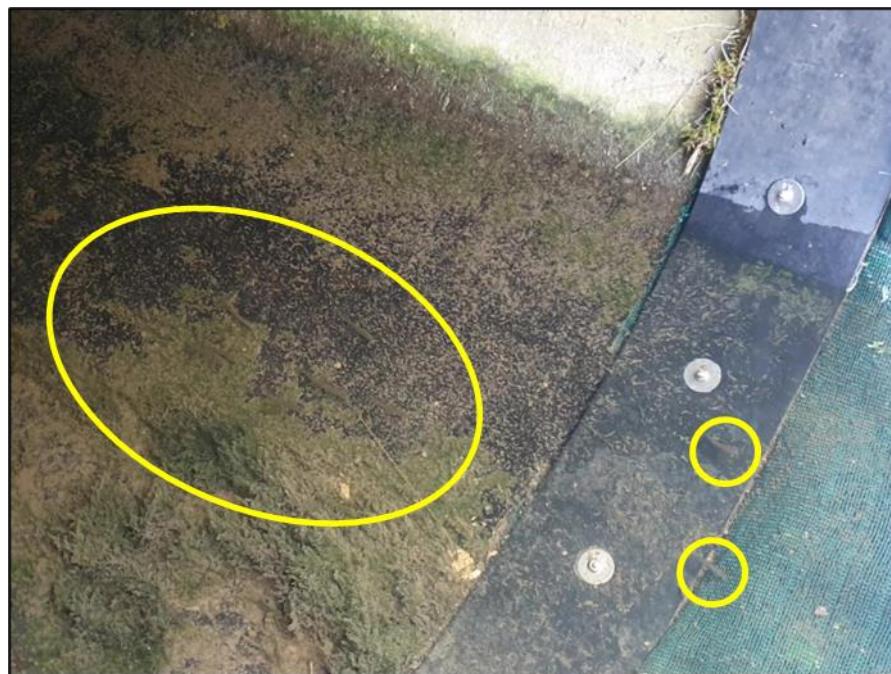
A large number of fish were caught within the remediated culvert at the conclusion of the trial. 58 fish were recovered including 36 inanga. Schools of galaxiid, some 20+ fish strong, were observed schooling around the remediation pipe inlet for several days prior to the trial conclusion. These fish were observed moving back and forth between the culvert pipe and the mouth of the A-frame net suggesting a possible disinclination to progress upstream into the net. If the A-frame nets at the top of the pipes were discouraging fish from moving into the “no return” area of the net, then this may explain the accumulation of fish within the barrel.

Figure 14. Schools of galaxiid feeding upstream of the topmost baffle (yellow circles)
