Client Report No 12072101

Client: Meika Kapa - Bay of Plenty Regional Council

Project: Effectiveness of floating ramp fitted with mussel-rope for facilitating fish access into a perched culvert.

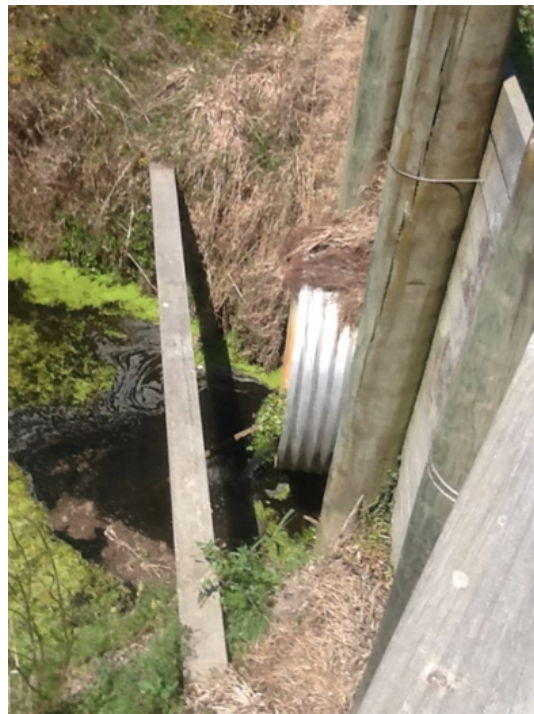
This is a private culvert on a tributary of the lower Rangitaiki River. The culvert is located approximately 12 km from the coast, with a diameter of 800mm, and is perched by 800mm with an undercut of 480mm. The culvert was identified as likely causing a barrier to fish migration. (Figure 1.).

Figure 1 - Outlet (December 2019)

Flow exited the culvert into a deep plunge-pool, presenting with significant scouring of the bed material.

The culvert barrel had no bed material, indicating that it was possibly a velocity barrier.

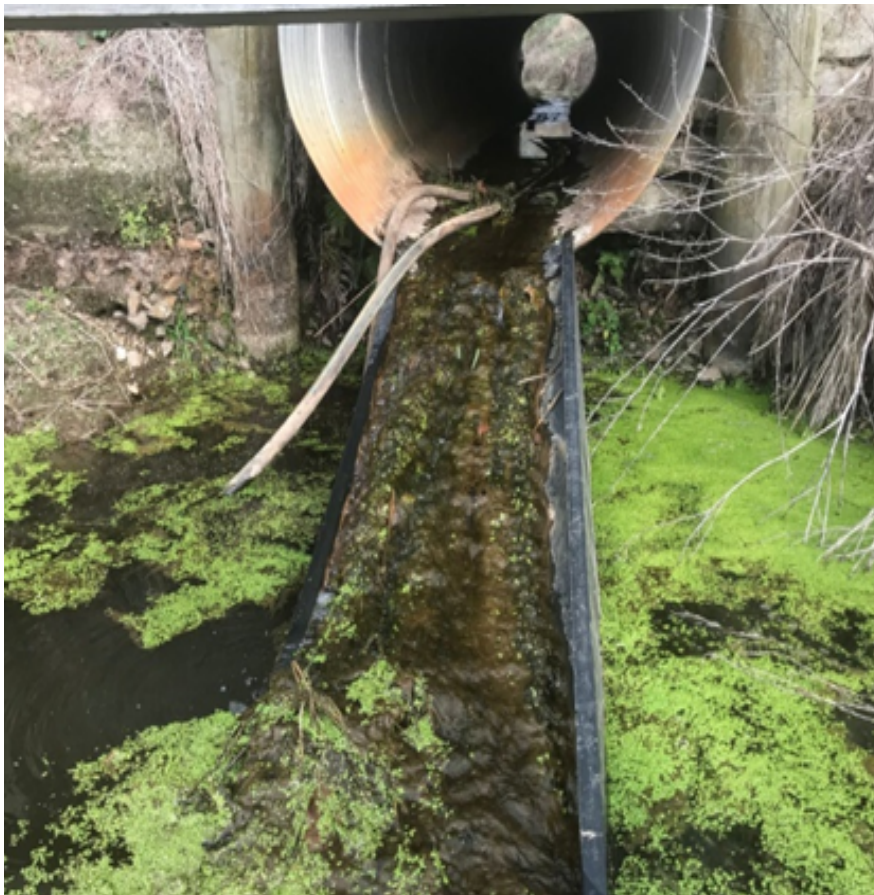
Figure 2 - Outlet (March 2020)

A 2.4-meter floating ramp (ATS-Environmental) at approximately 30° gradient at time of installation.

The ramp was attached to the culvert with a flexible rubber coupling.

The ramp has a 15° “V” and a smooth surface i.e. not Miradrain® dimples as featured in the NZ Fish Passage Guidelines.

8 lengths of mussel-rope were fitted down the ramp in 2 bundles of 4 strands instead of using Miradrain®.

The mussel-rope passes over a 100mm high flexible v-baffle with 45° cut ends, fitted 300mm up from the outlet of the culvert (Figure 2).

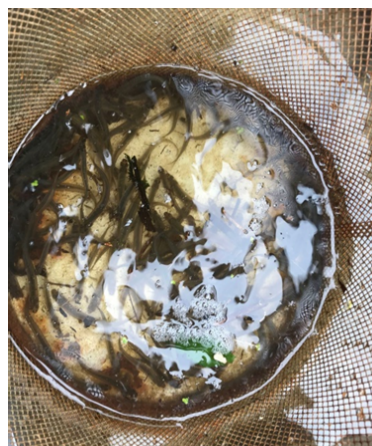
After remediation, a total of 4 fish (1 common bully, 3 inanga) were captured downstream, while 125 fish were captured upstream of the culvert (3 common bully, 1 short-fin eel, 121 inanga) (Figure 3.).

Figure 3 - Fish captured upstream - December 10th 2019
