Fish Passage Surveys

-Harley Road Culvert-

Olleycology Limited

8th March 2023 (revised 31st June 2023)

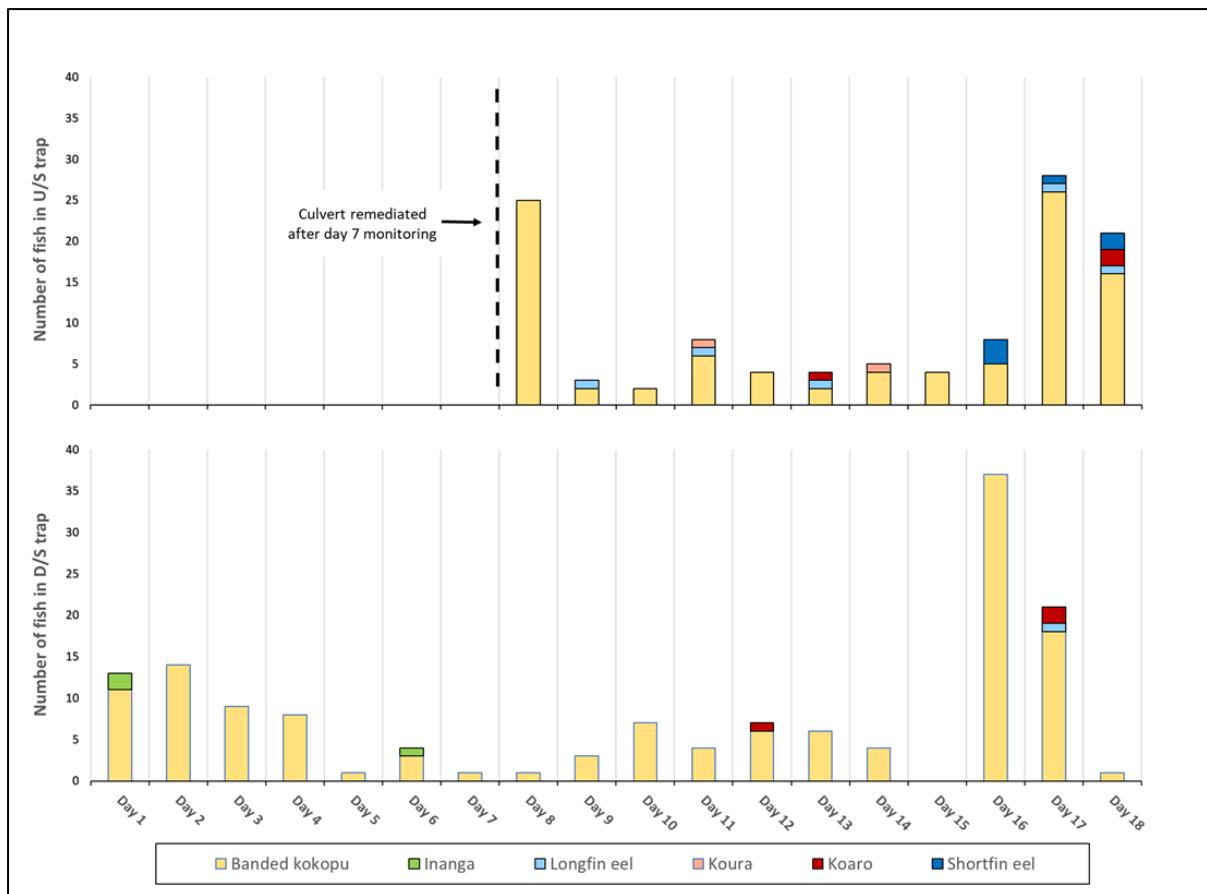
Figure 7. Numbers of fish caught in the A-frame nets upstream and downstream of the culvert pre and post remediation.

In the seven days prior to any remediation no fish were recovered from the upstream net (Figure 7).

Following fish passage remediation, a total of 110 fish were recovered from the upstream net over the 11 day post remediation survey period (Figure 7).

Three other species of fish were also recovered from the upstream net, three koaro (*Galaxias brevipinnis*) (size range 48-50mm), five longfin eels (*Anguilla dieffenbachii*) (size range 90-320mm) and six shortfin eels (*Anguilla australis*) (size range 88-128mm) (Figure 7). Two koura (*Paranephrops spp.*) were also found within the upstream net.

Over the full 18-day trial period, 141 fish were captured in the net placed downstream of the culvert. As with the top net, juvenile banded kokopu also dominated the catch with 134 fish recorded (size range 36-45mm) (Figure 7). Three other species of fish were also captured including three inanga (*Galaxias maculatus*) (size range 80-120mm), three koaro (size range 48-50mm) and one longfin eel measuring 91mm in length (Figure 7).

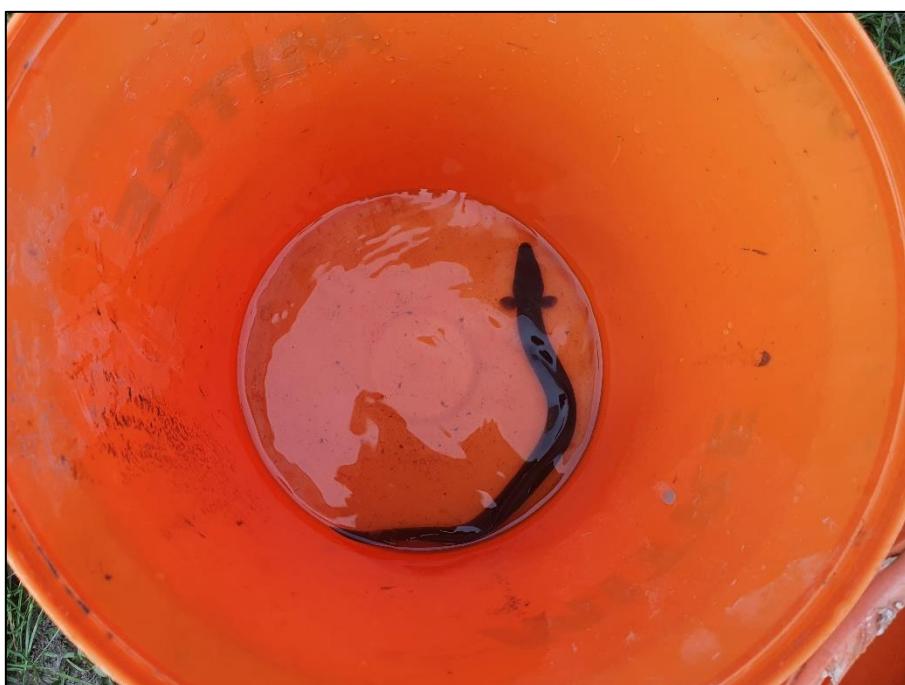
Both juvenile longfin and shortfin eels were recovered from the top net following remediation of the Harley Road culvert. However one larger longfin eel measuring 330mm in length was also recovered suggesting the ramps provide passage for a range of eel sizes (Figure 8).

Figure 8. Adult longfin eel caught in the upstream net.
