Fish Passage Surveys

-Williams Road Culvert-

Olleycology Limited

29th June 2022 (Revised 31st June 2023)

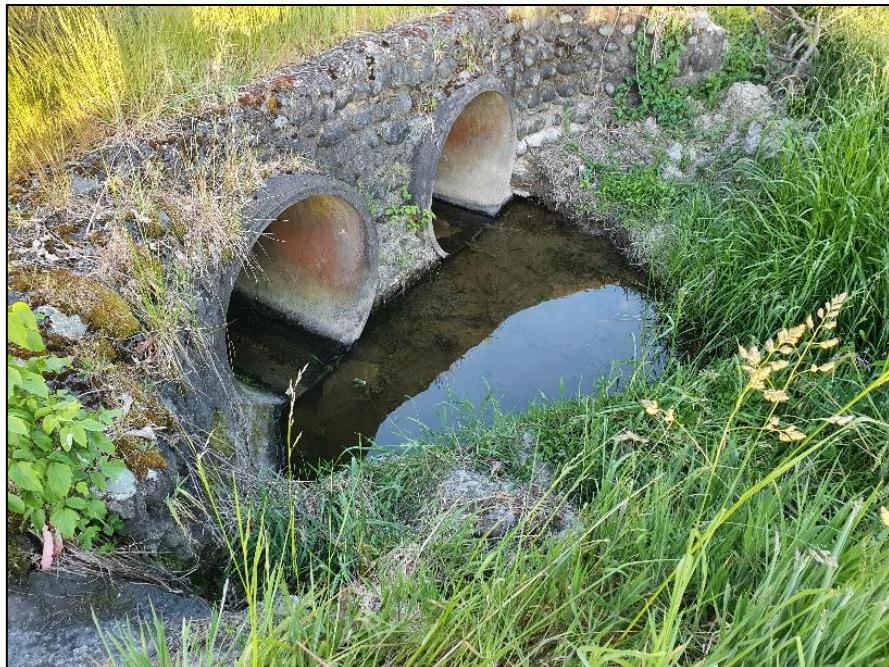
Figure 3. Culvert inlets at William's Creek.

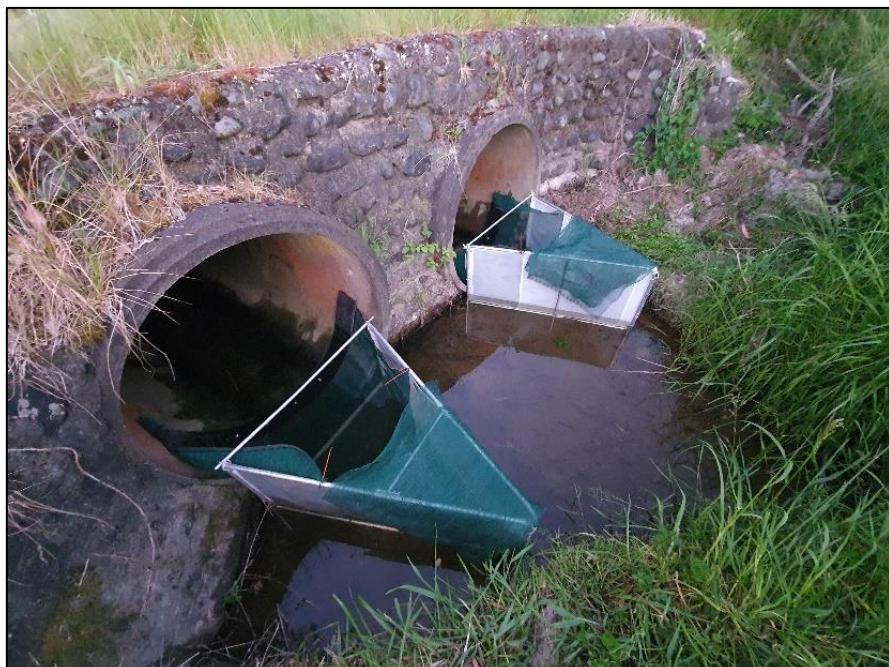
To assess the effectiveness of the remediation, an A-frame net was setup at the inlet of each of the culvert pipes to capture fish as they moved through each of the structures (Figures 3 & 4). This allowed for an impact (remediated pipe) and control (unremediated pipe) experiment setup. Fine mesh was used to ensure no gaps were present and the A-frame nets had “non return” zones (Figure 5). The nets were checked daily (in the morning) to collect, record and release fish. Fish were released upstream of the structure. Species and fish lengths were recorded along with conductivity and water temperature.

Figure 4. A-frame nets set upstream of both culverts.

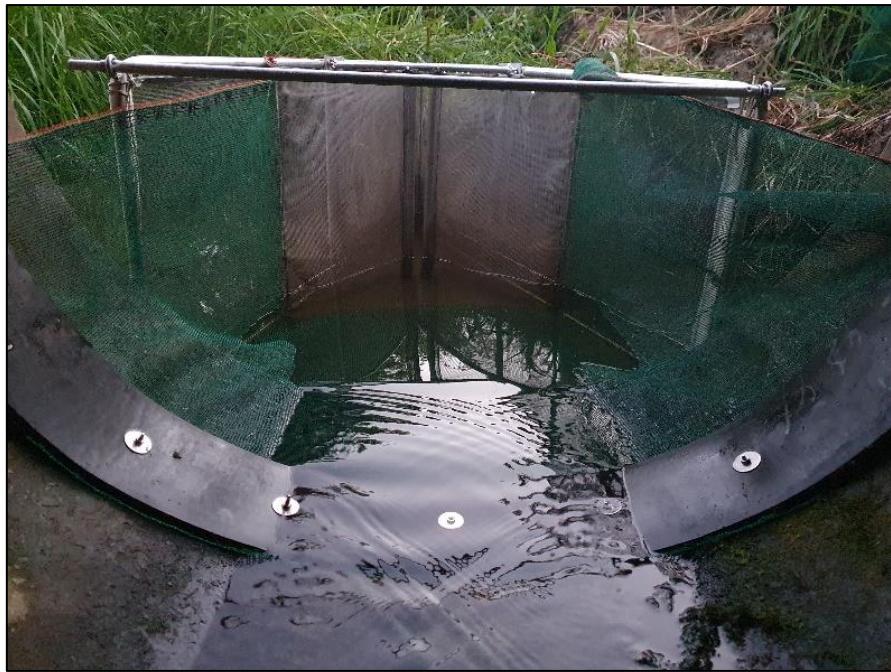
Figure 5. View from inside the true left-hand culvert looking upstream into the A-frame net.

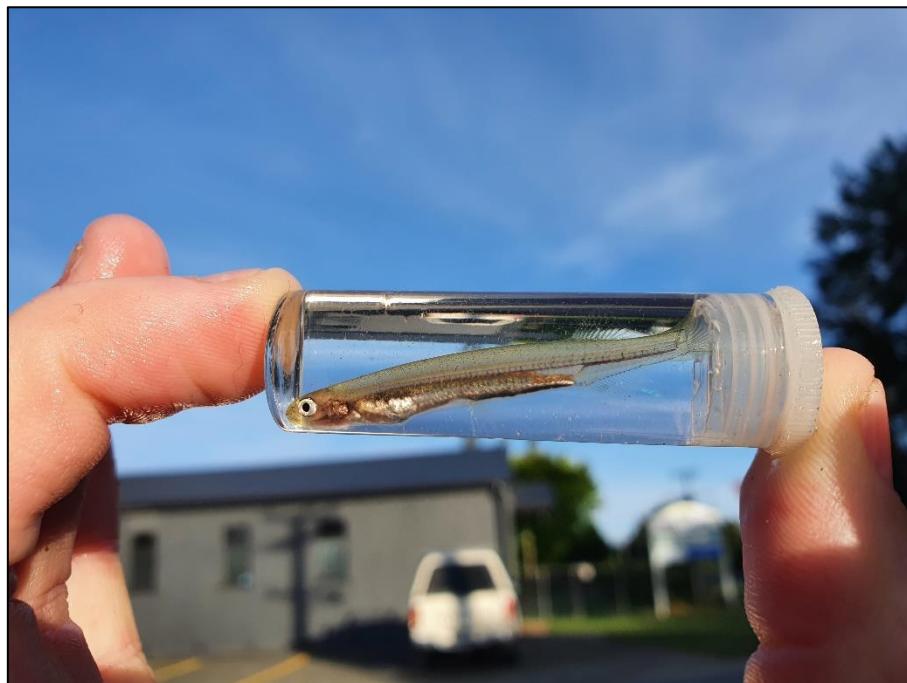
Two species of fish, inanga (*Galaxias maculatus*) and longfin eel (*Anguilla dieffenbachii*) were found only in the remediated culvert net. One longfin eel was captured in the remediated culvert net on day 13 while five inanga were captured in the remediated culvert net during the monitoring period (Graph 1). The size range for these inanga were 51-65mm in length.

Figure 11. An inanga captured on day 6
