Client Report No 12072101

Client: Meika Kapa - Bay of Plenty Regional Council

Project: Effectiveness of floating ramp fitted with mussel-rope for facilitating fish access into a perched culvert.

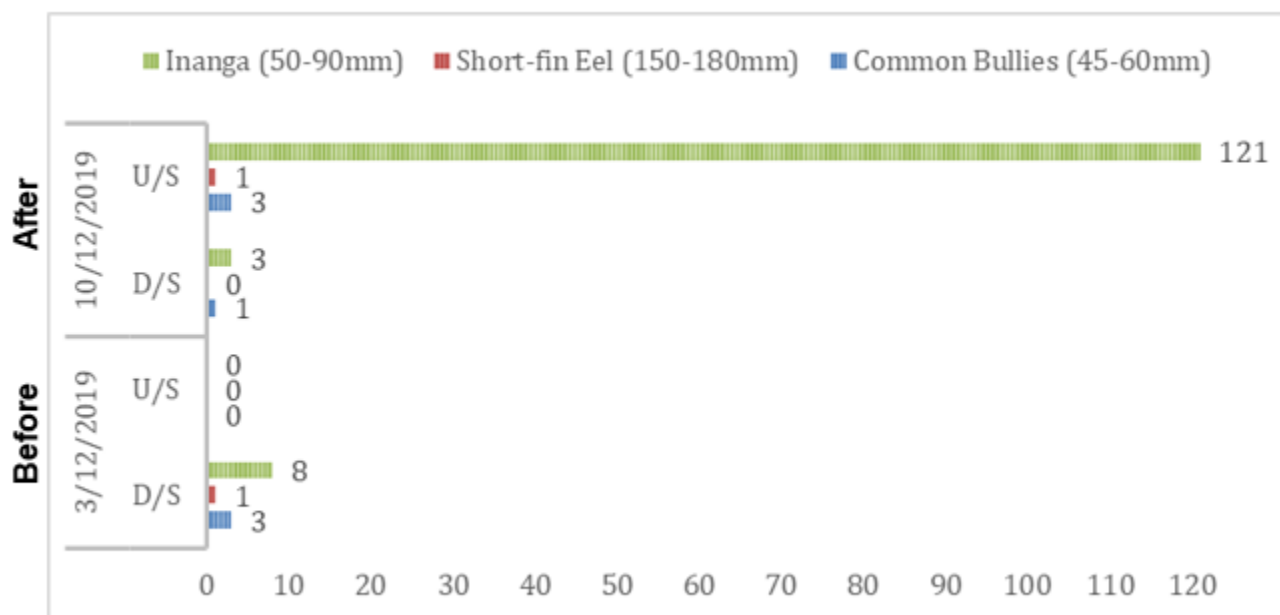
Table 1 - Data results

Pre-remediation survey found a total of 12 fish downstream of the barrier (8 inanga, 1 short-fin eel, 3 common bully), with no fish captured upstream of the culvert (Table 1.).

After remediation, a total of 4 fish (1 common bully, 3 inanga) were captured downstream, while 125 fish were captured upstream of the culvert (3 common bully, 1 short-fin eel, 121 inanga) (Figure 3.).
