Tasman District Council's Jobs for Nature Fish Passage Evaluation Report - 2024/25 season -

Prepared for:
Tasman District Council

Prepared by:
Tim Olley¹, Ricky Olley¹ and Robin Holmes²
¹Olleycology Limited
²Cawthron Institute

22nd October 2025

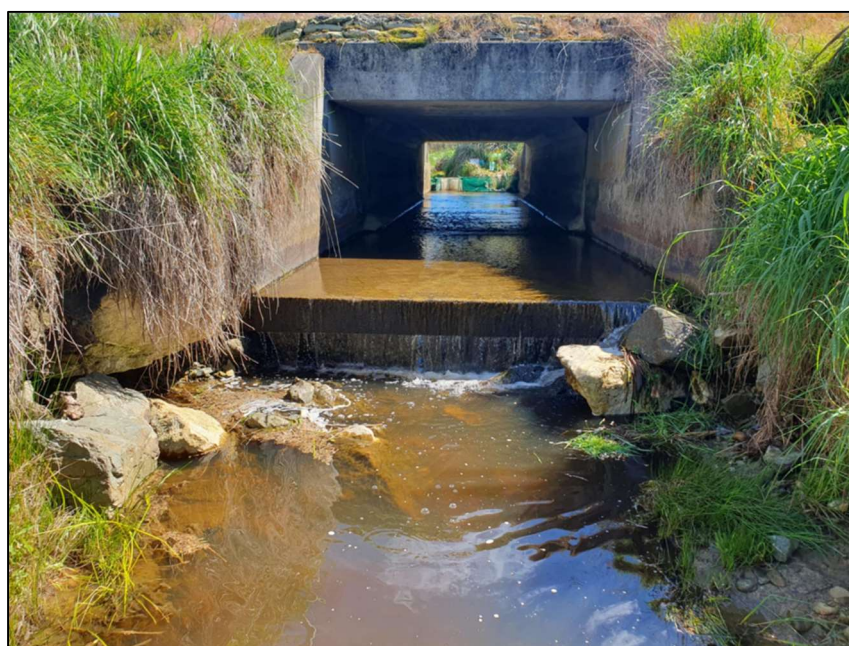
Dominion Stream is a third order stream which flows into the Waimea Inlet in Tasman Bay. Approximately 70m upstream of its confluence with the Waimea Inlet, Dominion Stream flows through a concrete box culvert under Mapua Drive (Figure 1). This structure is the first barrier fish would encounter while moving up from the coast. The culvert is 3.0 m wide by 1.5 m high and 18 m long. At the commencement of the evaluations at Dominion Stream on the 18th of October 2024, the culvert was undercut 320 mm, had a perch height of 550 mm, and a gradient of 0.5%. The maximum water velocity through the culvert was recorded at 0.3 m/s.

Figure 1. Perched box culvert at Dominion Stream prior to the beginning of the fish passage evaluations, October 2024

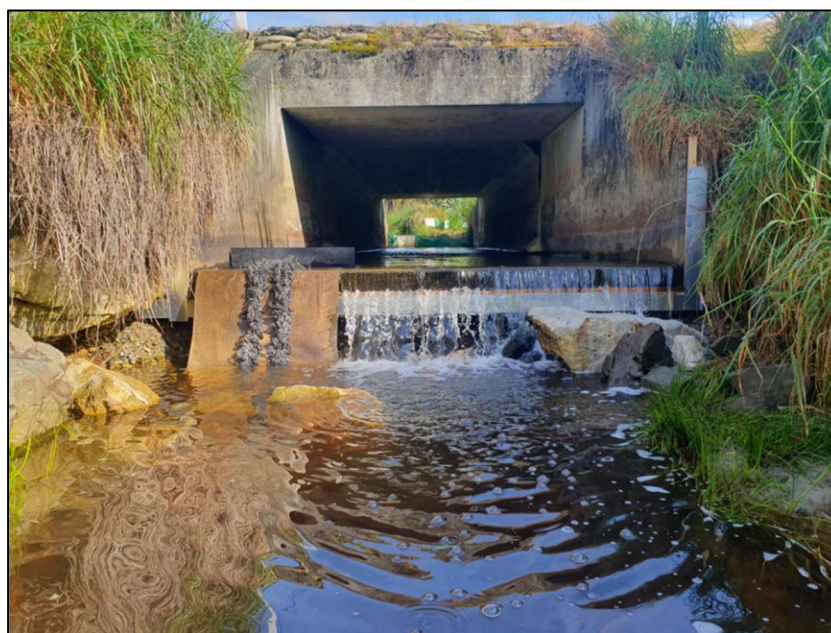
With reference to the Fish Passage Remediation Training Aid (Olley et al 2022), a flexible rubber fish ramp was installed on the true right hand side of the outlet of the culvert (Figure 2). The ramp was 900 mm wide by 1300 mm long and lay near vertical. The distance down the ramp between the culvert invert and the water level was 600 mm.

One Flexi-baffle was secured onto the culvert apron to steer water away from the ramp. The baffle was 900 mm wide and 150 mm high.

Figure 2. Dominion Stream culvert remediated with a flexible rubber ramp.

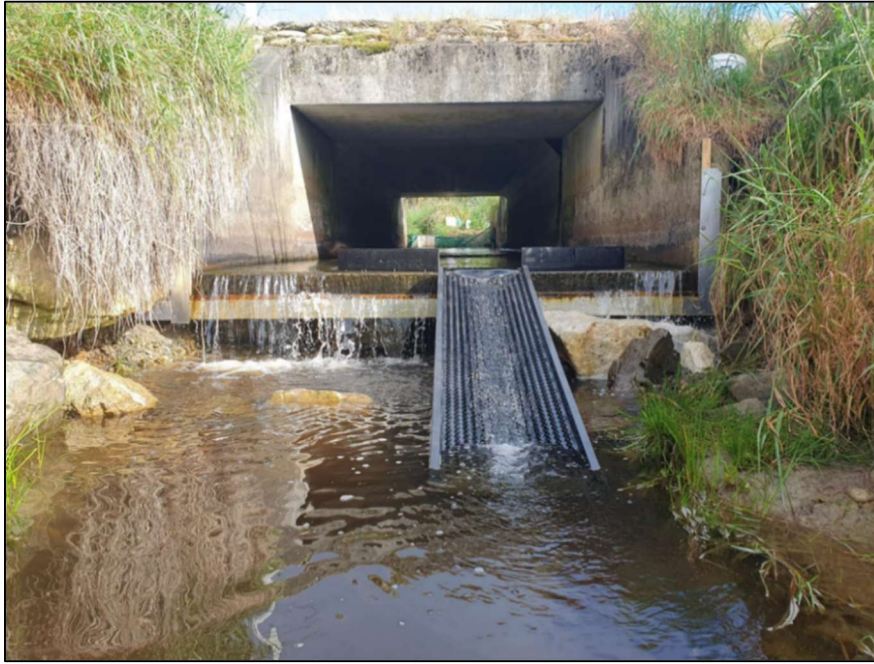
With reference to the Fish Passage Remediation Training Aid (Olley et al 2022) and NZ Fish Passage Guidelines (Franklin et al 2024), a plastic floating fish ramp was installed at the centre of the culvert outlet (Figure 3). The ramp was 540 mm wide and 2400 mm long and lay at a gradient of 15.5 degrees. The distance down the ramp between the culvert invert and the plunge pool was 2100 mm.

Two Flexi-baffles were secured onto the culvert apron to steer water towards the ramp. The baffles were 900 mm wide and 150 mm high.

Figure 3. Dominion Stream culvert remediated with a single floating fish ramp.

The installation of the single floating ramp examined in the release and recapture trial was the same as in the in situ trial, however, because of the low stream flows at the time of the trial, additional Flexi-baffles were used on the culvert apron to match the flow down the ramp with the flow where high numbers of Inanga were found to use the single ramp in the in situ trial. For a description of this remediation treatment see page 5: Treatment 2.

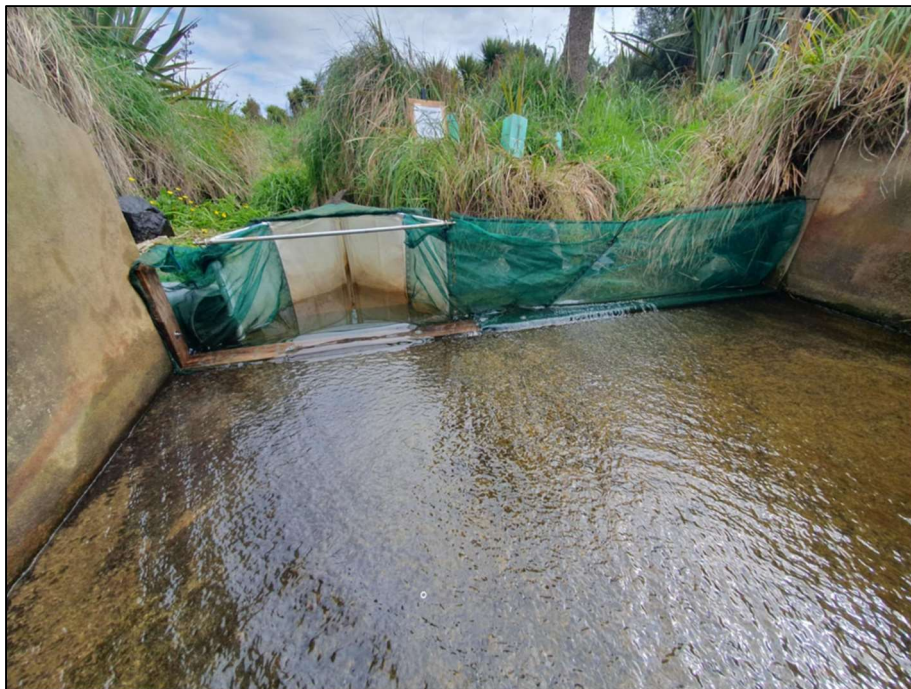
An A-frame fish trap was installed at the culvert inlet to capture fish that successfully entered and negotiated the culvert during the trial period. Because the culvert width was wider than the inlet trap entrance, mesh screens were used to block upstream movement out of the culvert. The inlet trap entrance and base of the screens were secured firmly to the base and side walls of the culvert so that the only upstream pathway for fish was into the trap, and so that passage into the inlet trap was not compromised. The inlet trap was designed with “non-return” zones to prevent fish from escaping (Figure 5).

Figure 5. Inlet A-frame trap and screening wings at the Dominion Stream box culvert.

An A-frame fish trap was installed at the culvert inlet to capture fish that successfully negotiated the culvert during the trial period. Because the culvert width was wider than the inlet trap entrance, mesh screens were used to block upstream movement out of the culvert. The inlet trap entrance and base of the screens were secured firmly to the base and side walls of the culvert so that the only upstream pathway for fish was into the trap, and so that passage into the inlet trap was not compromised. The inlet trap was designed with “non-return” zones to prevent fish from escaping (Figure 5).

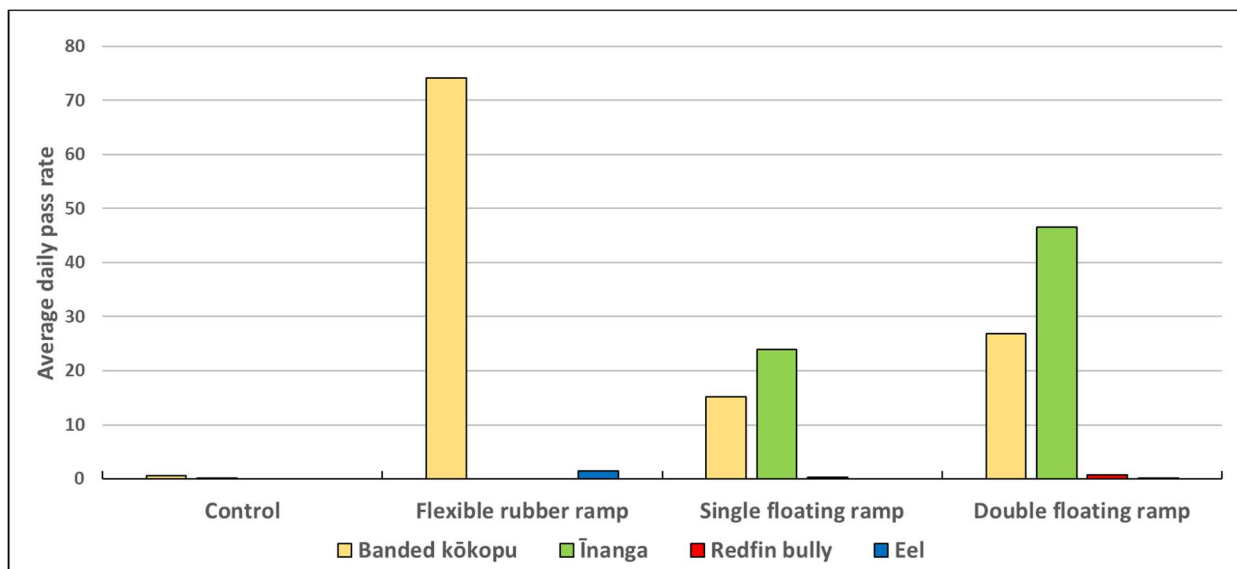
The average daily pass rate for banded kōkopu was 0.6 fish per day during the control treatment, 74.1 fish per day over the flexible rubber ramp, 15.2 fish per day over the single floating ramp and 26.9 fish per day over the double floating ramp (Figure 7).

The average daily pass rate for īnanga was 0.1 fish per day during the control treatment, 0 fish per day over the flexible rubber ramp, 24 fish per day over the single floating ramp and 46.6 fish per day over the double floating ramp (Figure 7).

Figure 7. Average daily pass rates of all species for each remediation treatment over the trial period.

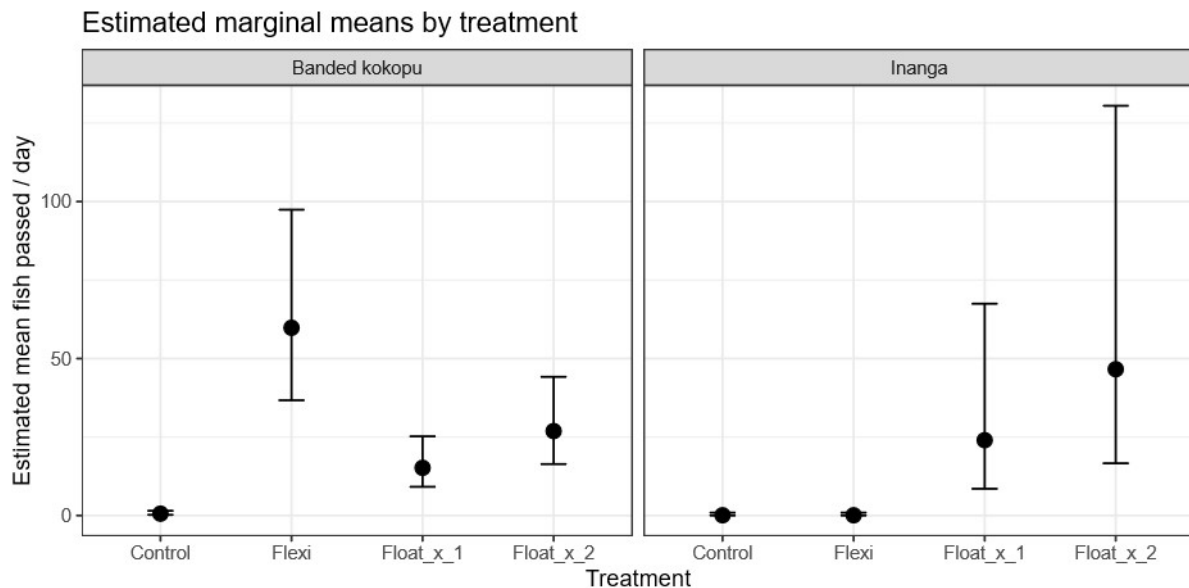
All treatments significantly improved passage for banded kōkopu relative to the control treatment. The flexible rubber ramp was significantly better for banded kōkopu passage than the single floating ramp but not the double floating ramps. The double floating ramp was not significantly better than the single floating ramp (Figure 8).

For Īnanga the flexible rubber ramp did not differ significantly from the control treatment, indeed, no Īnanga used the flexible rubber ramp over the trial period. The single floating ramp significantly improved Īnanga passage relative to the control treatment, but the double floating ramp was not significantly better than the single floating ramp (Figure 8).

Figure 8. Estimated marginal means and 95% confidence intervals for fish passed by structure per day by treatment for banded kōkopu (left) and Īnanga (right)

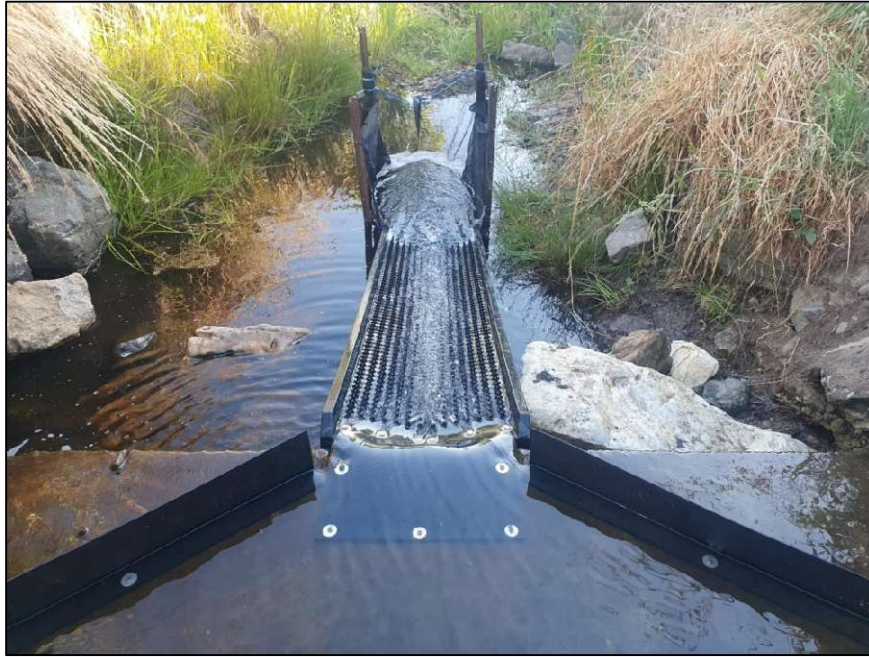
A single floating ramp was installed at the outlet of the culvert, and an outlet net was created around the base of it within the culvert plunge pool (Figure 10). The outlet net was constructed of fine mesh (0.5mm) material and had within it areas of low velocity where fish could rest.

Figure 10. Single floating ramp and outlet net at the Dominion Stream box culvert.

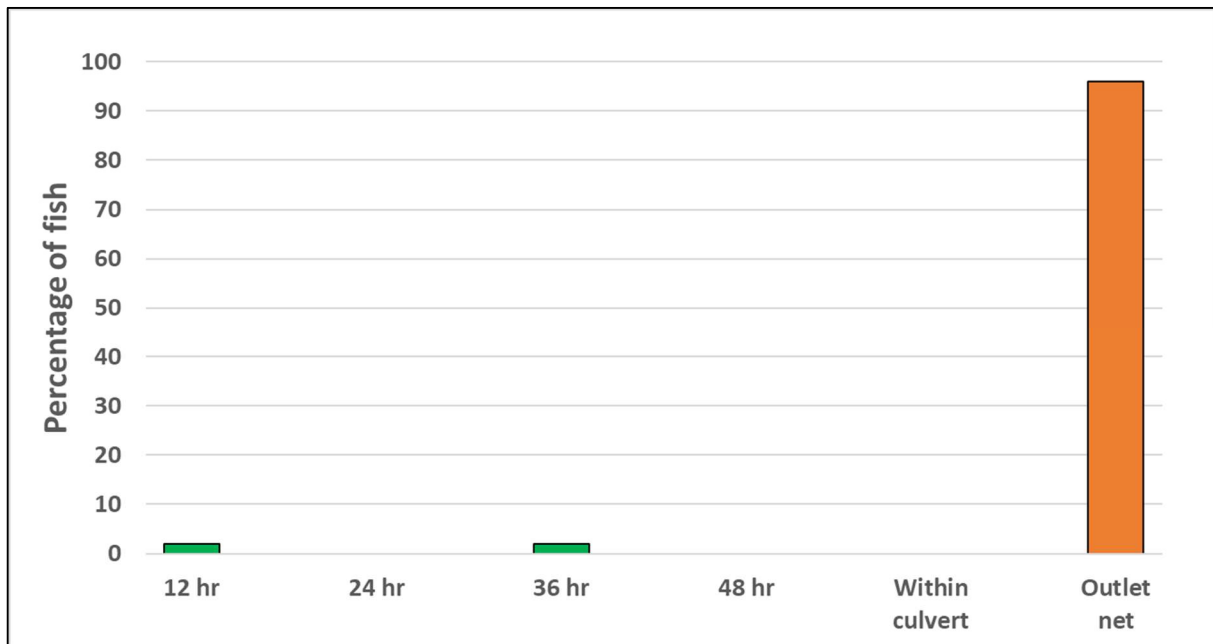
A total of four fish (4%) successfully swam up the single floating fish ramp and through the culvert (Figure 11). No fish were recovered from within the culvert after the 48hr trial period and 96 fish were captured from the outlet net having failed to negotiate the ramp.

Figure 11. The percent of successful fish recovered from the culvert inlet trap after each twelve hour time period is shown as green bars. Also shown is the percent of successful fish recovered from within the culvert (blue bar), and the unsuccessful fish recovered from the outlet net (orange bar) after the full 48 hour time period.

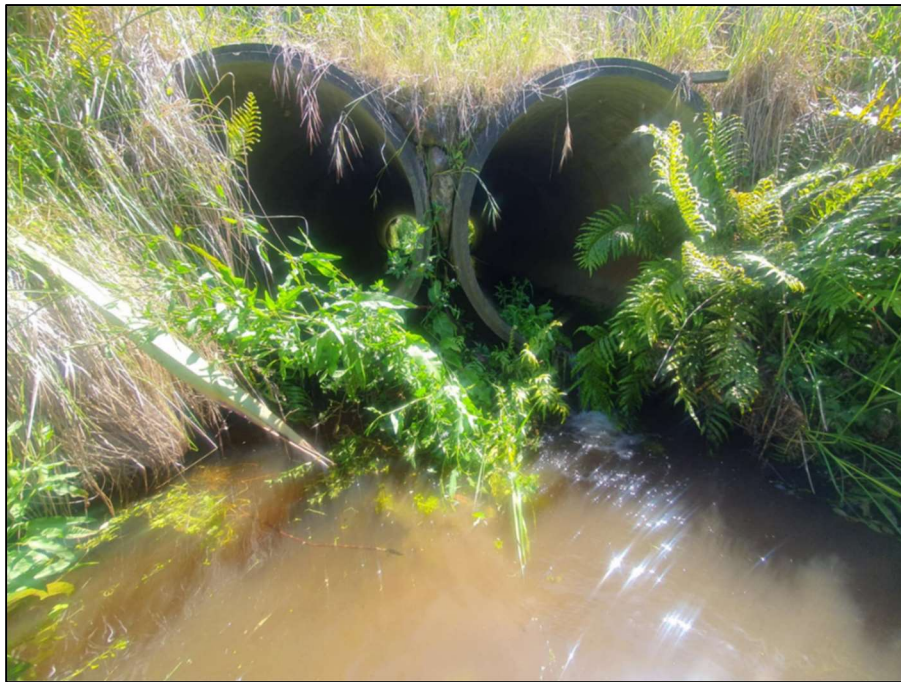
Williams Creek is a small tributary of Tasman Valley Stream which flows into the Moutere Inlet in Tasman Bay. Diadromous fish species with a predicted presence greater than 10% include īnanga, banded kōkopu, giant kōkopu, long and shortfin eels, and common bully (Leathwick 2008). Approximately 500 m upstream of its confluence with Tasman Valley Stream, Williams Creek is piped through two concrete culverts where it crosses Williams Road (Figure 13). This crossing is located about 1.5 kms inland from the Moutere Inlet and is the second barrier fish encounter when moving upstream from the coast. Both culverts are 1200 mm in diameter, 9.6 m long and have gradients less than 1%. Under base flow conditions, the entire stream flows through the true left hand culvert, and therefore this was the culvert chosen to complete the trial. At the commencement of the evaluations at Williams Creek on the 18th of November 2024, the flow rate through the true left culvert was 2.1 L/s. The maximum water velocity through the culvert was recorded at 0.3 m/s.

Figure 13. Perched round culverts at Williams Creek prior to the beginning of the fish passage evaluations, November 2024

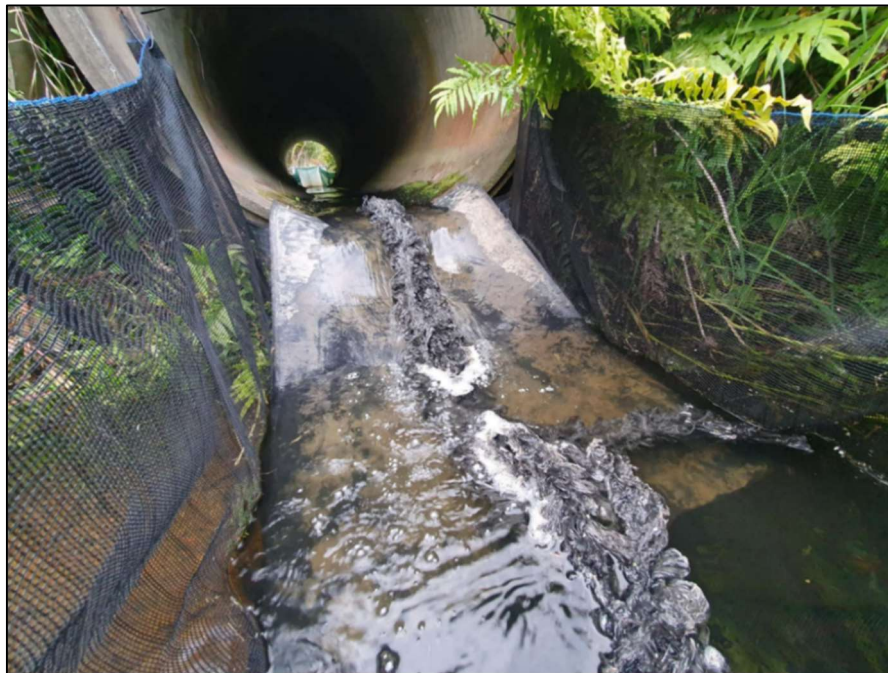
With reference to the Fish Passage Remediation Training Aid (Olley et al, 2022), a flexible rubber ramp was installed at the outlet of the culvert (Figure 14). The ramp was 750 mm wide by 1200 mm long and the gradient was approximately 37 degrees for each of the three perch heights. For each of the three perch heights the distance between the culvert invert and the plunge pool was 370 mm at a 150 mm perch, 470 mm at a 200 mm perch and 570 mm at a 250 mm perch.

Figure 14. Remediation at Williams Creek showing a flexible rubber ramp.

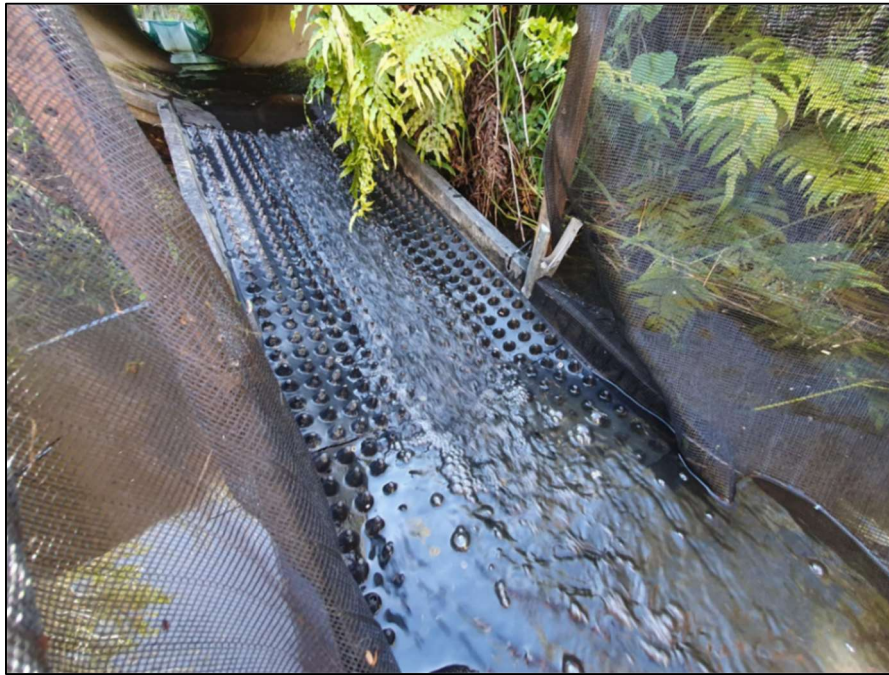
With reference to the Fish Passage Remediation Training Aid (Olley et al 2022) and NZ Fish Passage Guidelines (Franklin et al 2024), a plastic floating fish ramp was installed at the culvert outlet (Figure 15). The ramp was 540mm wide and 1500mm long and lay at a gradient of approximately 12.5 degrees. The distance down the ramp between the culvert invert and the plunge pool was 1150 mm at a 250 mm perch.

Figure 15. Remediation at Williams Creek showing a floating ramp.

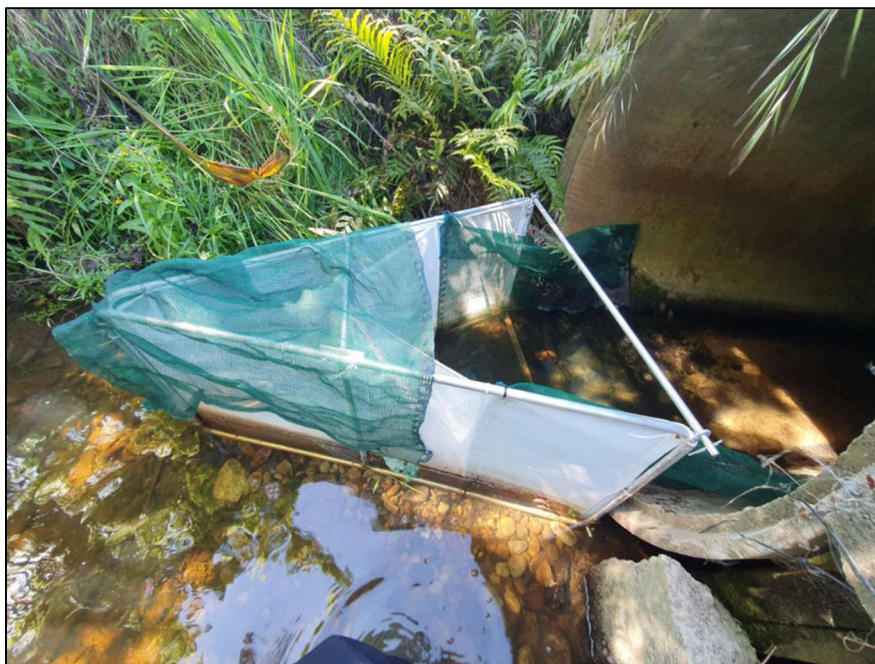
An A-frame fish trap was installed at the culvert inlet to capture fish that successfully negotiated the ramp and culvert during the trial period. The inlet trap entrance was secured firmly to the base and side walls of the culvert so that the only upstream pathway for fish was into the inlet trap, and so that passage into the inlet trap was not compromised. The inlet trap was designed with “non-return” zones to prevent fish from escaping (Figure 16).

Figure 16. Inlet A-frame trap at the Williams Creek culvert.

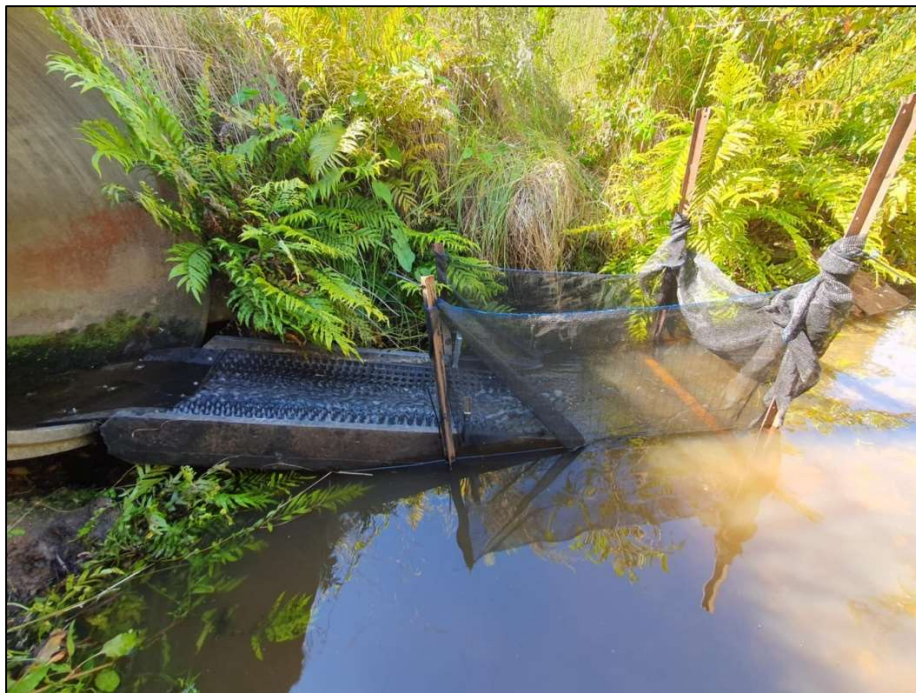
An outlet net was created around the base of both the flexible and floating ramps within the culvert plunge pool (Figures 17 & 18). The outlet net was constructed of fine mesh (0.5mm) material and had within it areas of low velocity where fish could rest.

Figure 17. Single floating ramp and outlet net at the Williams Creek round culverts.

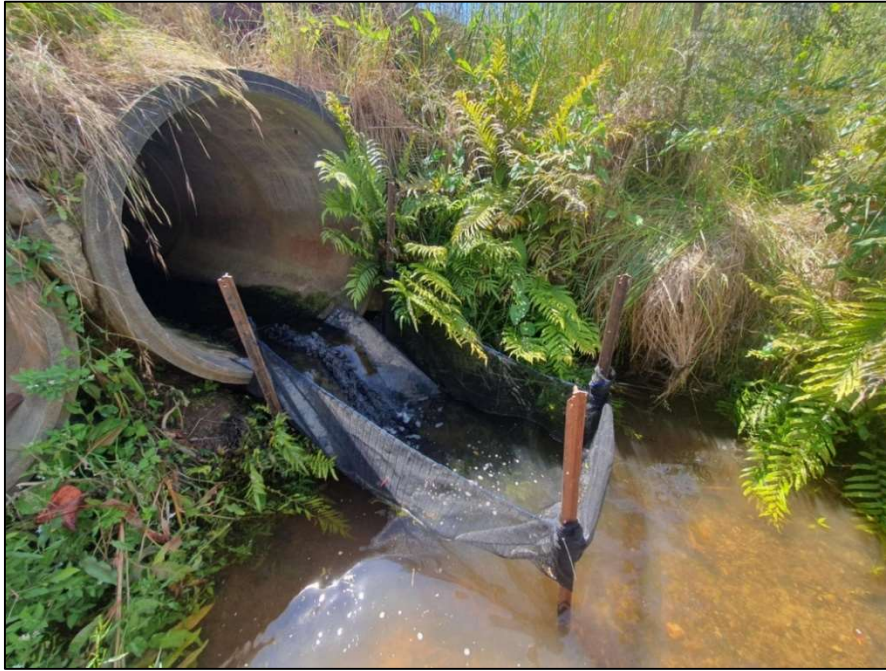
Figure 18. Flexible rubber ramp and outlet net at the Williams Creek round culverts.

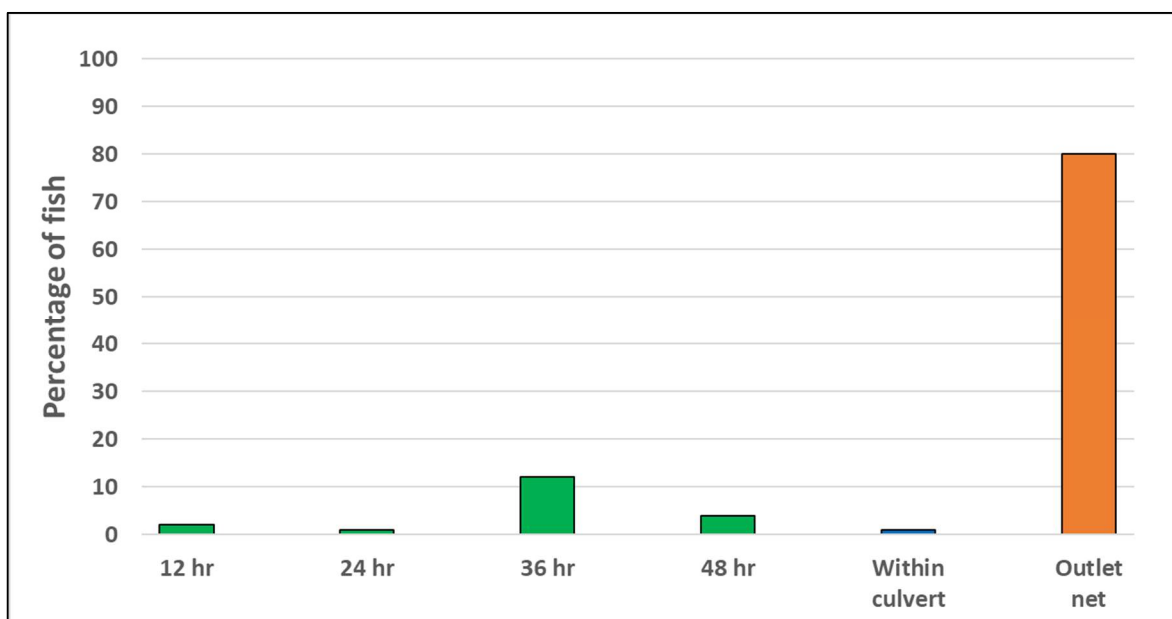
Figure 21. For the flexible rubber ramp trial over a 250mm perch the percent of successful fish recovered from the culvert inlet trap after each twelve hour time period is shown as green bars. Also shown is the percent of successful fish recovered from within the culvert (blue bar), and the unsuccessful fish recovered from the outlet net (orange bar) after the full 48 hour time period.

Trials		Portion of fish (%)		
Perch height (mm)	Remediation	Top Net	Within culvert	Outlet net
150	Flexible ramp (Figure 19)	48	6	46
200	Flexible ramp (Figure 20)	43	1	56
250	Flexible ramp (Figure 21)	19	1	80
250	Floating ramp (Figure 22)	68	18	14
